## A complex reinforced structure applied at hilly road repair case in Taiwan

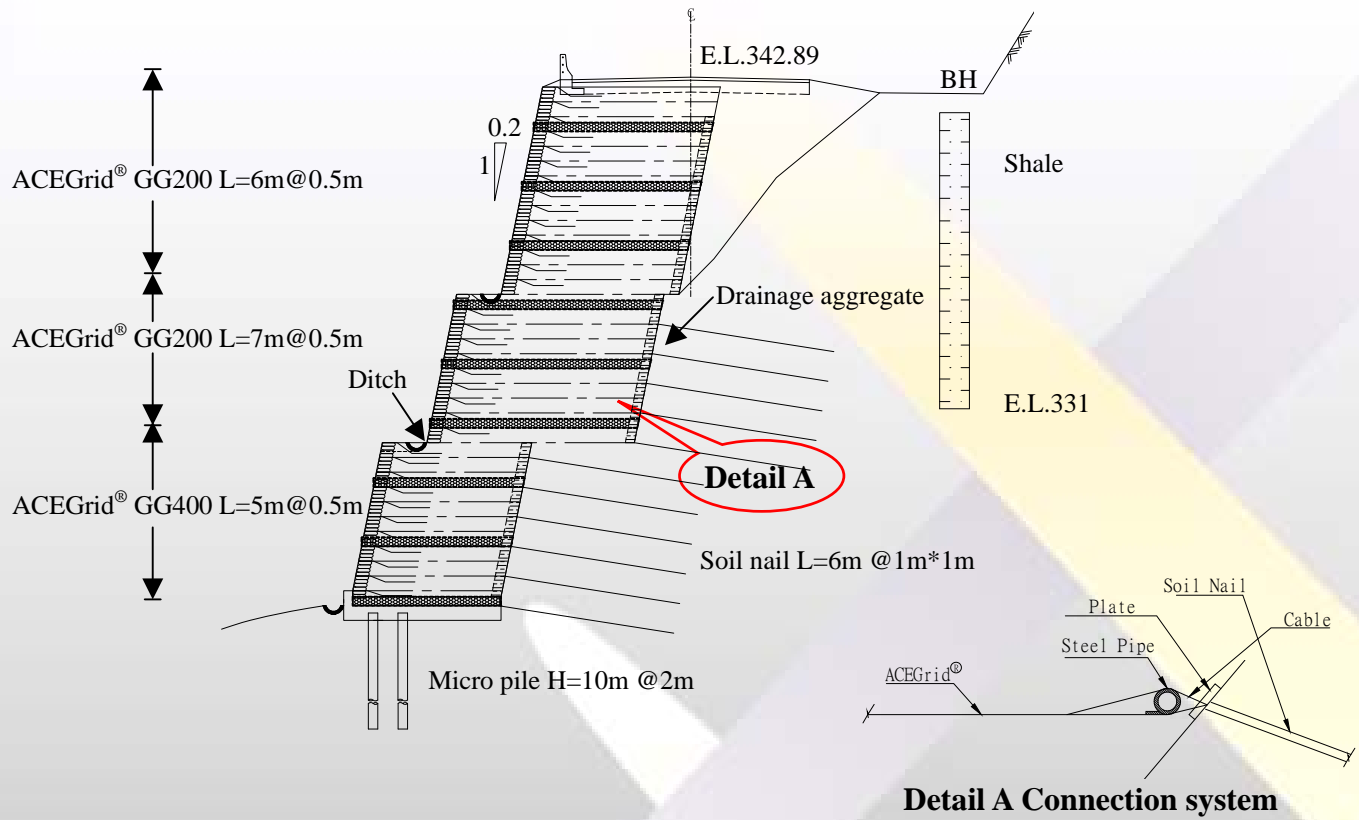
**Figure 1. Cross section of design drawing**

The reinforcement construction began from the bottom of destroyed slope and completed the reinforcement of lower layer before next higher layer was established. When the expected height was reached, soil nails should be served by drilling machine. (see Figure 1)

In view of the fact that short buried distance for geogrid might cause a structural failure, one simple but wise connection system was invented to competently correct the problem. Please refer to Detail A Connection system in Figure 1, the notion of the connection system is to guide the stress of geogrid

perpendicular to the forwarding direction of the route. Steel pipe attaches to the reinforced plate of soil nail through galvanized steel wire strand. Thus, once the geogrid goes around the steel pipe and gets fixed on the ground by anchor bars, the mechanics is completed. All steel components of the connection system should be galvanized as to reach the corrosion protection.

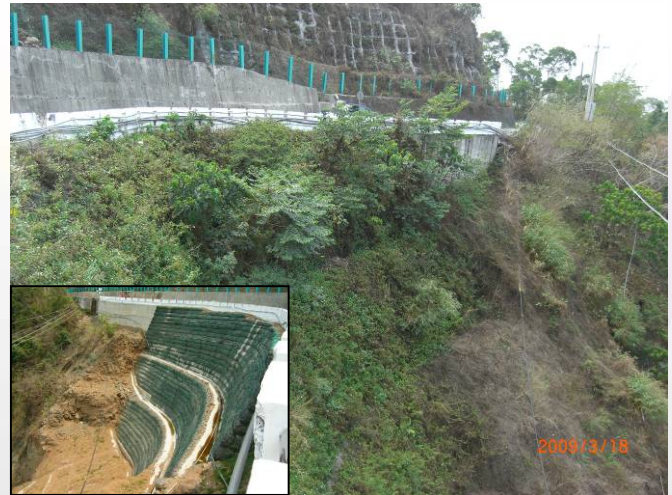
**Figure 5. After construction**

Majia County Highway 35 project was found in the fatality zone. What makes us feel comfortable and honor is the complex reinforced structure not only is intact but looks green in this depressing injured town after ruthless Morakot.
