## Landslide restoration project in Taoyuan, Taiwan

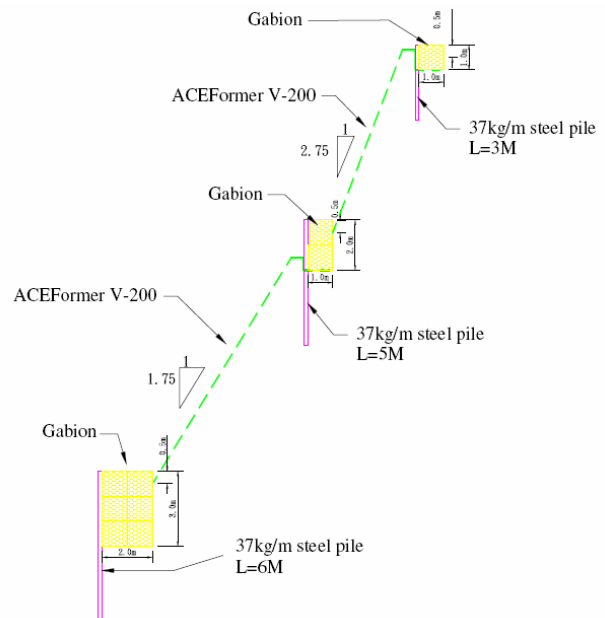
Figure 1. Design drawing

design institution buried 6m<sup>3</sup>, 24m<sup>3</sup>, 72m<sup>3</sup> ACEBag-g each at the top, offset, and toe; then, laid a steel pile with length 5m each 1m intervals(Figure 1). Moreover, a vegetative ACEFormer was used to prevent slope from being eroded. When finished filling, the single-layer area without irrigation was removed, seeds of plantation were sprayed within the open area, and lastly one tree was grown every 3m<sup>2</sup>.

It was distinguished by two stage with up and down, and slope length were 10m and 15m, area were 108m<sup>2</sup> and 186m<sup>2</sup>, the offset distance was 1.5m. In order to protect the slope toe,

The project spent the total area of 1.05 times the slope which is about 309m<sup>2</sup>, and it was expected to attain 20cm height after filling. ACEFormer was formed by interwoven double-layer of high tenacity woven geotextile of PET and PP. In order to meet the filling and anchor tension requirements, the tensile strength of fabric was set biaxial 50kN/m, the permeability rate was greater than 900L/min/m<sup>2</sup> to allow to filter out the excess water and AOS was 0.4mm for preventing leakage of filling material.

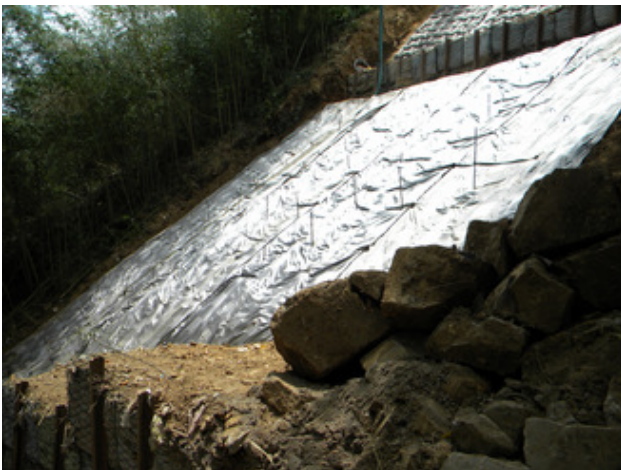
Figure 2. Before filling

Laying direction of ACEFormer was from top to bottom, and right to left. ACEFormer was horizontally overlapped at a width of 50cm, and the right stage was overlaid above the left stage. Due to the slope inclination reached 70 degree, in order to avoid the ACEFormer from sliding down during filling process, steel rail stakes are anchored at top of each layer and steel bars are fixed on the surface of laid ACEFormer. Before filling, worker cut an opening about 20cm in the appropriate location at the top of ACEFormer, and inserted the filling irrigation pipe, then proceeded to start filling from right to left.

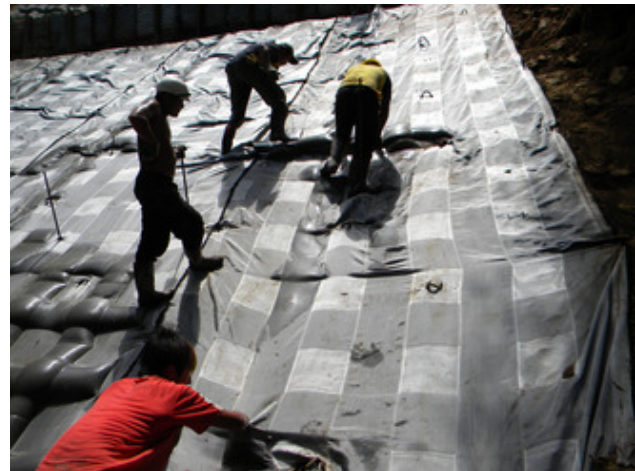
Figure 3. During filling

The filler is 1 : 3 cement mortar, the amount of filling material is about  $0.1 \text{ m}^3/\text{m}^2$ . As a result of steep slope, if filling the ACEFormer completely in once, it will vary too much weight and size, so the thickness of the top and the toe will be different and uneven. For this reason, one-piece ACEFormer must be filled three times. After each time to fill, worker should wait for the cement mortar initial set and then continue filling. In this project, the construction was accomplished within a day.

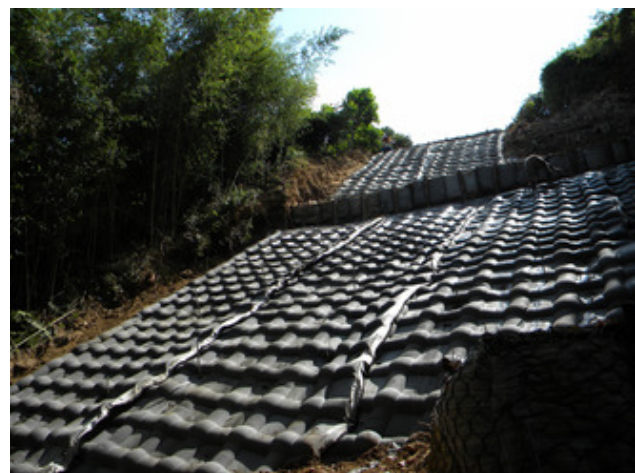
Figure 4. After construction

The outcome of ACEFormer after finished filling, the convex-shaped part of the surface can reduce the water flow velocity and increase anti-erosion ability. Moreover, vegetative ACEFormer can also grow trees and vegetation to reach the effectiveness of soil and water conservation. In conclusion, ACEFormer is easy construct and provides high efficiency for project needs.
