ACEGrid® a Hilly Road Repair Project in Thailand

Location : Ranong Province, Thailand

Application : Road Repair

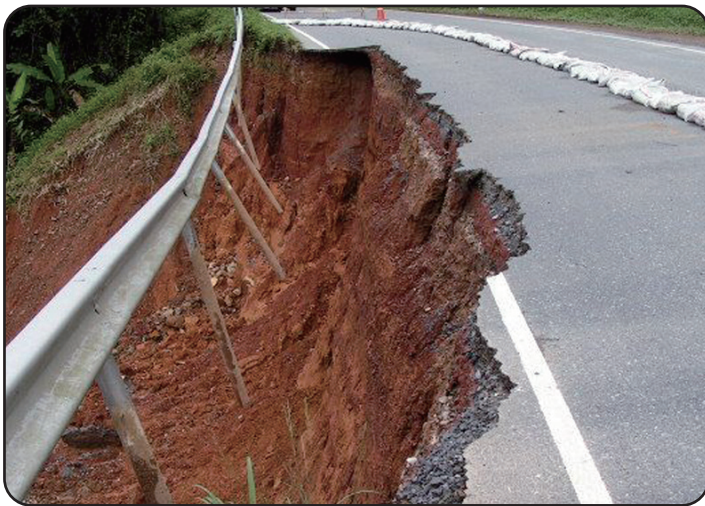
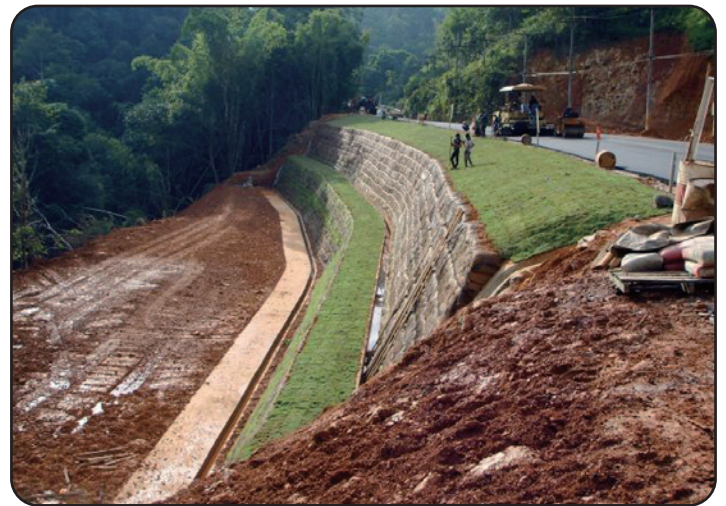
This hilly road repair case was located at Km.8 Ranong-Pato Road, Ranong Province, Thailand. During heavy rainy season, roadway was inundated easily owing to the blockage of drains. A great deal of rainwater converged and flowed downwards to the slope of roadway, the slope surface was eroded by rainwater steadily as a result of lacking in drainage system. Simultaneously, plenty of water infiltrated into soil layer, leading to the loss of shear strength of deep soil layer and causing circular sliding. Eventually, the roadway upon the collapse, resulting in only single lane was passable subsequently.

To restore the convenience of transportation, the designer, Department of Highways, adopted reinforced structure with the height of 8 meters, the slope of less than 70 degrees ($V : H = 1 : 0.5$). Two-stage, each is 4 meters in height and RC slab was constructed to protect the toe of structure. According to stability analysis, ACEGrid® GG100-I was proposed as the reinforced material. In order to make the appearance of the reinforced structure go well with the green surrounding, facing system by piled soil bags to be the plant growing medium. Moreover, to prevent the structure from the damage caused by erosion problem due to the lack of drainage system, the designer configured transverse intercepting ditches and vertical gutters respectively as drainage system at the boundary between reinforced structure, RC slab and the surface of original slope.
