Provincial Road No. 7A Reconstruction at Yilan County in Taiwan

Location: Yilan County, Taiwan

Application: Road Construction

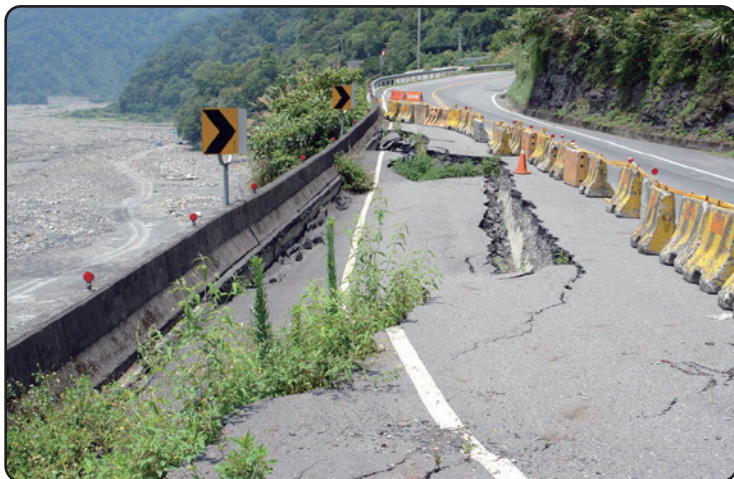
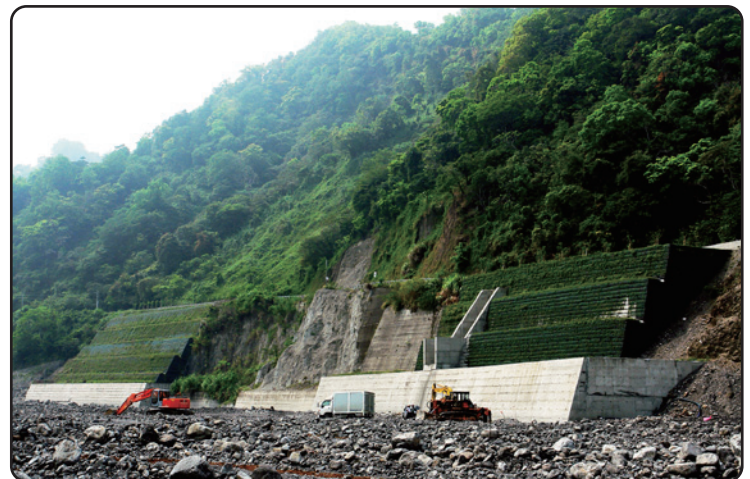
During two and half months, from 16th July to 29th September 2008, Taiwan was attacked by six typhoons, the accumulated precipitation brought by four of the six typhoons exceeded 945mm in Yilan area according to the statistic from Central Weather Bureau. Heavy rain damaged section 1k+300 and 1k+500 of Taiwan Provincial Road No. 7A next to Lanyang River Basin. Due to the damage, the traffic was only accessible in single lane. The field investigation stated that Lanyang River was in spate after the torrential rain brought by typhoons. Strong current scoured the foundation of roadway and the scouring of soil at downslope toe led to the collapse of upper roadway.

Owing to the main issue of this project - scouring at slope toe, to prevent from recurrence damage and consider the economical and convenient construction method, designer took the solution of reinforcement structure to construct 40-meter-long and 80-meter-long repair projects along the original road line and adopted ACEGrid[®] GG120-II, GG160-II, GG240-II as well as GG250-II as reinforced material, respectively. Soil nails were driven in the rear of reinforced structure to enhance the stabilization of inherent slope. Good permeability materials, sand and sandy gravel, were used as the backfill soil for the reinforced retaining wall. External drainage system at offset of each stage, drainage pipe in the interior of the structure and drainage board at the rear of backfill soil, most important of all, thanks to the good permeability of granular soil used for the backfill area, the construction progress was not delayed by rainfall. The design achieved an artificial structure combining safety, excellent drainage and eco-landscape.
