## A complex reinforced structure applied at hilly road repair case in Taiwan

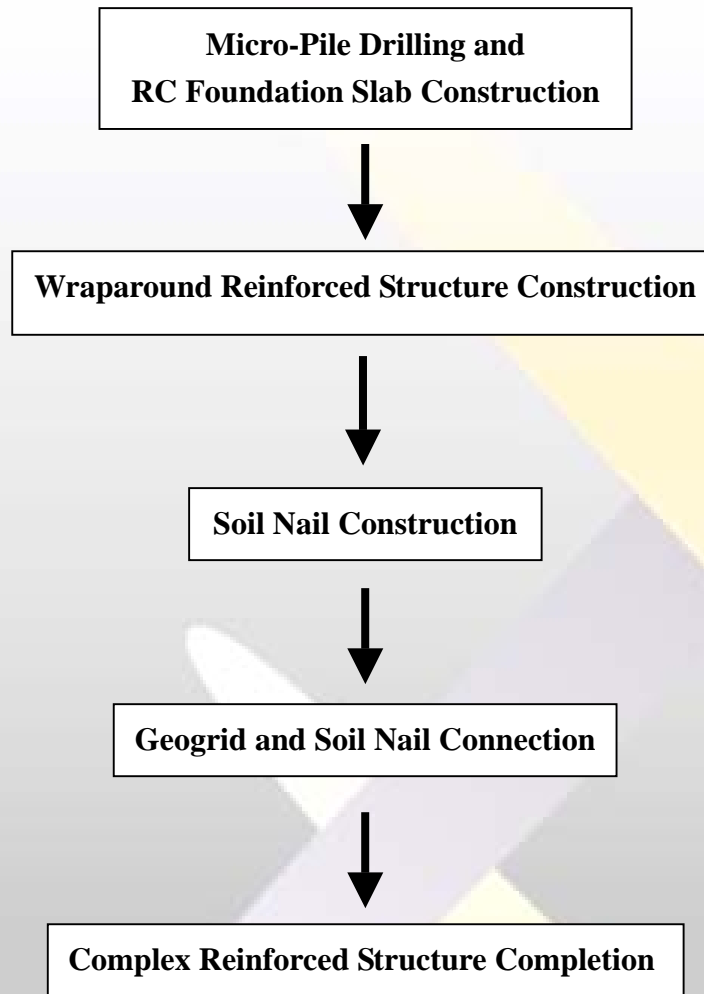
**Figure 2. Construction process**

The reinforcement construction began from the bottom of destroyed slope and completed the reinforcement of lower layer before next higher layer was established. When the expected height was reached, soil nails should be served by drilling machine. (see Figure 1)

The design concept and installation procedure of the complex reinforced structure are stated as follows and showed in the flow chart (see Figure 2).

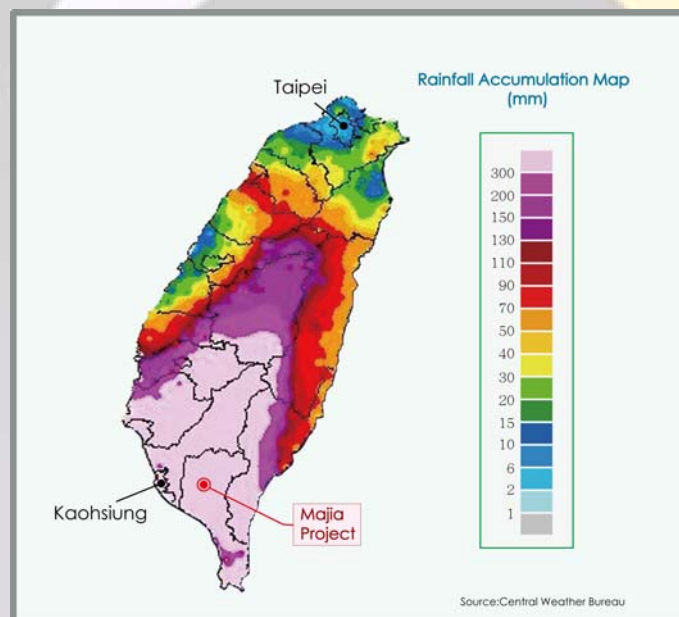
**Figure 3. Rainfall Accumulation Map**

Morakot swept Philippines, Taiwan, as well as Zhejiang province in China horizontally and impacted the tender lands severely. From 7th to 10th August Morakot had brought more than 1000mm rainfall to Pintung mountain area, CWB (Central Weather Bureau) stated. In accumulated rainfall map (see Figure 3), it shows the maximum rainfall was situated in whole South Taiwan.

Majia County Highway 35 project was found in the fatality zone. What makes us feel comfortable and honor is the complex reinforced structure not only is intact but looks green in this depressing injured town after ruthless Morakot.
