## *Coastal Dune Protection Using ACETube® in Mexico*

*Location: Las Coloradas, Mexico*

*Application: Coastal Protection; Sand Dune Reinforcement*

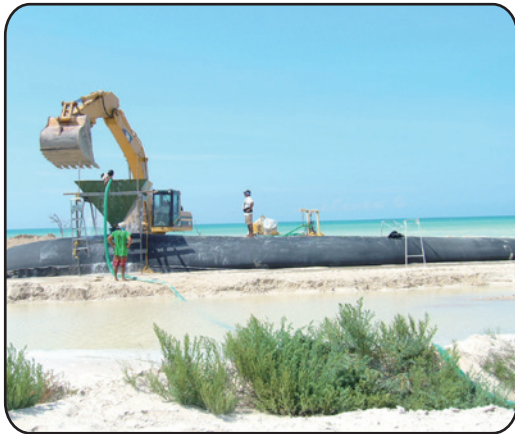
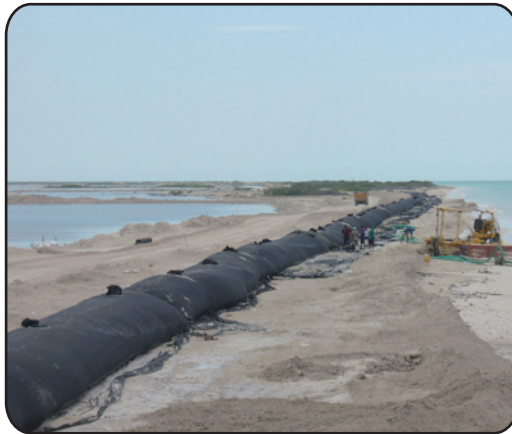
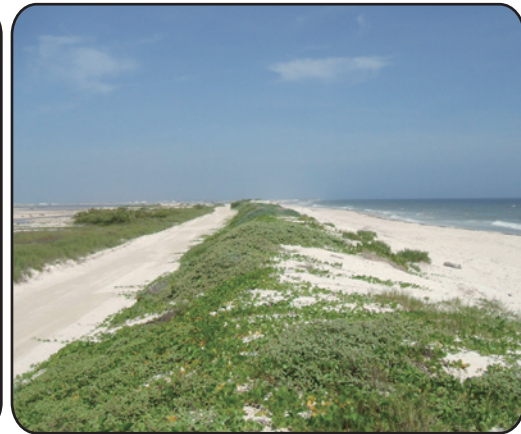
To protect the region from further damage caused by hurricanes, ACE Geosynthetics has done an ACETube® application in cooperation with Axis Ingenieria and ML Ingenieria for Industria Salinera de Yucatan in Mexico. ACETube® is filled from a hopper to the filling ports with the pumping seawater and dumping sand from an excavator producing slurry as filling materials. Once ACETube® are filled, they would be covered with sand to reach design height. Right after the construction is completed, dunes started natural vegetation's growth. Periodically the conditions of the tubes are checked and after the 2006 storm season from October through December, some parts are needed attention but don't influence the safety of whole structure. In conclusion, the whole structure provided the well performance in the salt production lagoons protection without affecting coastal process and natural evolution of surrounding beaches. In terms of environmental impact which is a priority concern in every coastal project, the flexibility of ACETube® represents a great alternative after individual designed.
